Technical Note N-515

EVALUATION OF A HYDRO-PNEUMATIC FLOATING FENDER OR CAMEL

June 1963

U. S. NAVAL CIVIL ENGINEERING LABORATORY
Port Hueneme, California

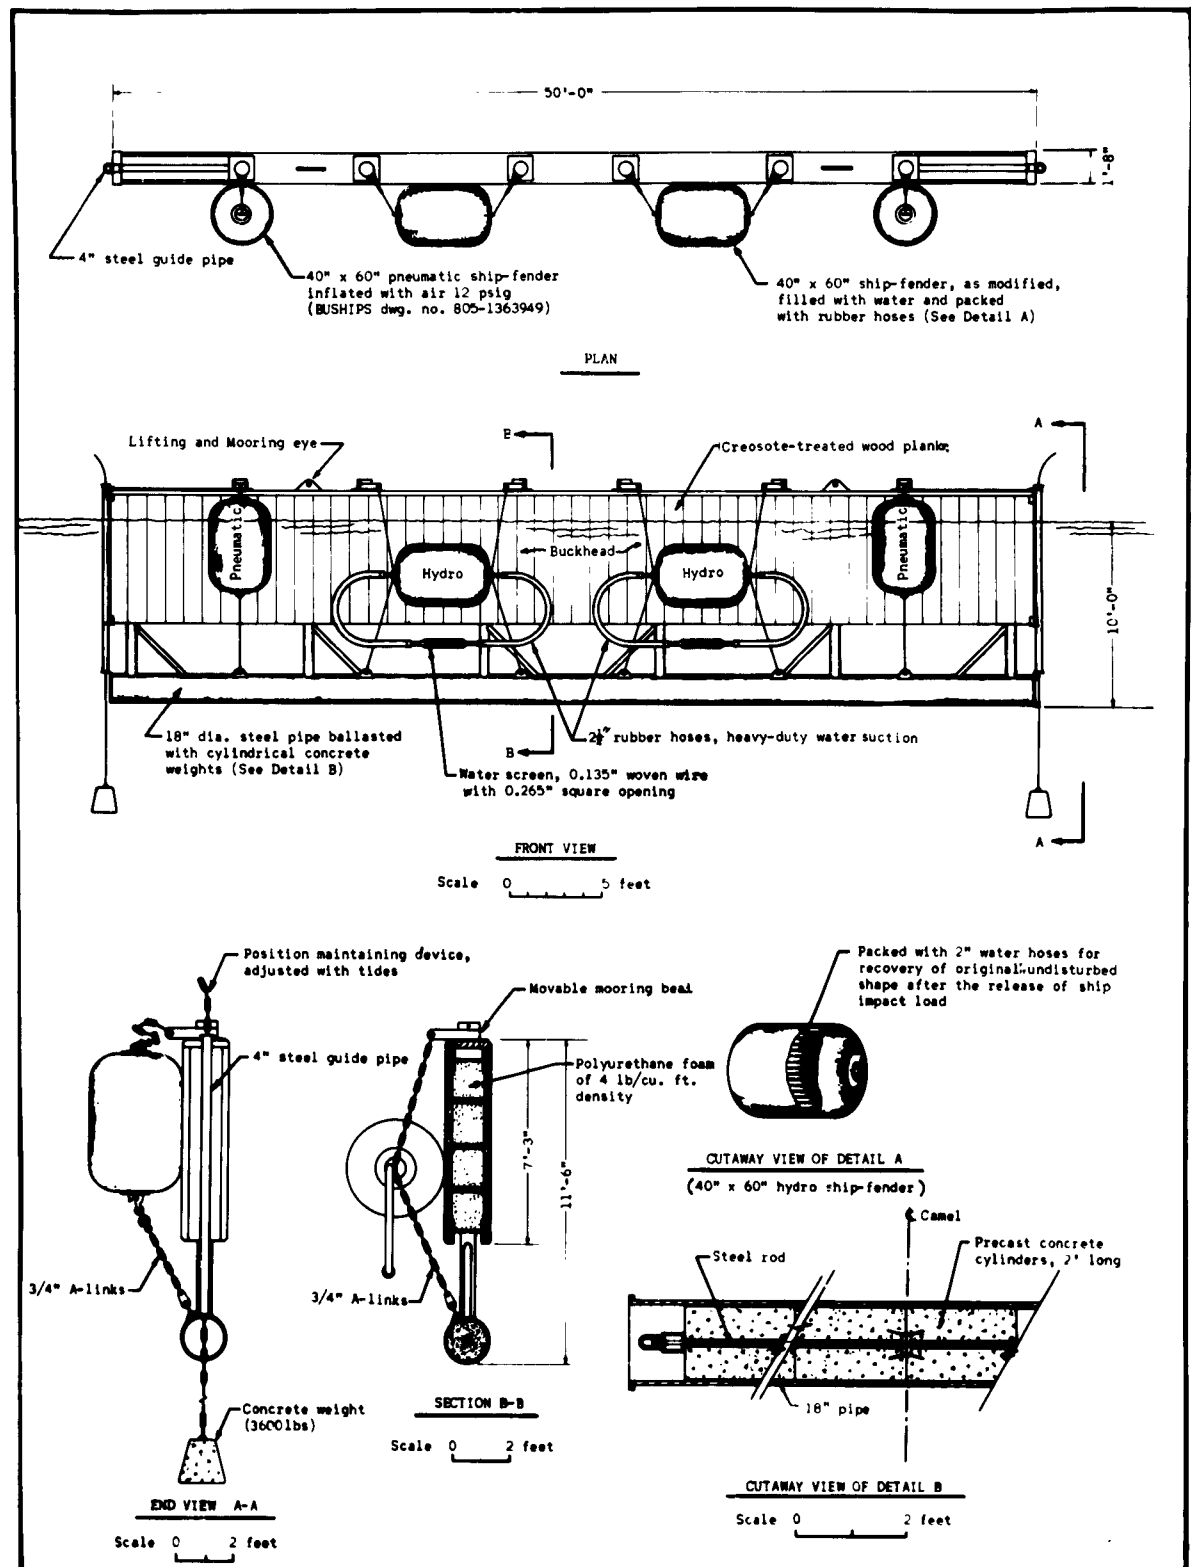
Figure 1 Hydro-pneumatic Energy Absorbing Camel

NOTE: This figure was prepared based on Y & D Dwg No. 946116 and 946117, as modified by NCEL.

The basic element in the BUDOCKS-designed NCEL-tested camel is a 50-foot long, 1'8" wide, 11'6" high floating bulkhead (Figure 1). The bulkhead is protected by two 40" x 60" pneumatic rubber ship-fenders with a minimum 6.6 psig or higher, up to 24 psig, initial air pressure, and two similar fenders filled with water. These rubber cushion units have a total minimum energy-absorbing capacity of 20 foot-tons and a maximum of 86 ft-tons. However, in practice, only a few rubber fenders make contact with the ship; therefore, even the minimum total energy-absorption capacity is not utilized. For recovery purposes, the water-filled fenders are packed with rubber hoses which serve to spring the fenders back to their undisturbed shape after the ship's load is removed. They are secured to the bulkhead with their axis horizontally instead of vertically as for the pneumatic fenders. An 18" pipe filled with sectional concrete cylinders is used as ballast weights.

The camel has two lifting and mooring eyes located approximately 10 feet from each end. In addition, a position maintaining device, not in the original design, was provided (Figure 1). The energy-absorbing characteristics of both hydro and pneumatic fenders are shown in Figures 2 and 3. It will be noted that each hydro-fender will absorb a maximum energy of 25 ft-tons as compared with 18 ft-tons (initial air pressure 24 lb/in²) for pneumatic fenders, assuming in both cases maximum pressure of 50 lb/in² which is the working strength of the rubber fenders. The impact load will not exceed a maximum allowable load of 40 tons on the ship's hull. Naval architectural characteristics are shown in Table I.

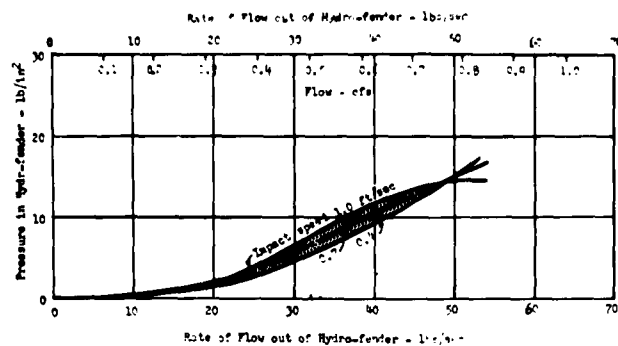
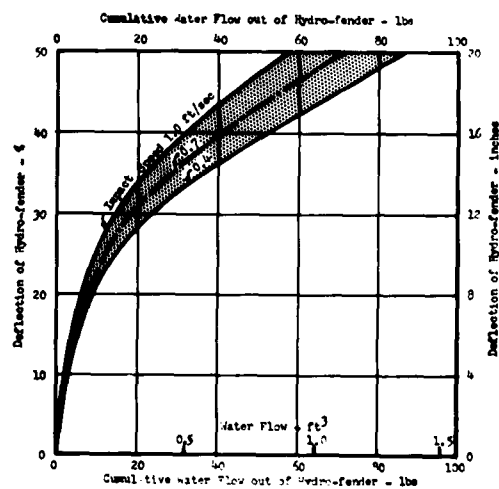
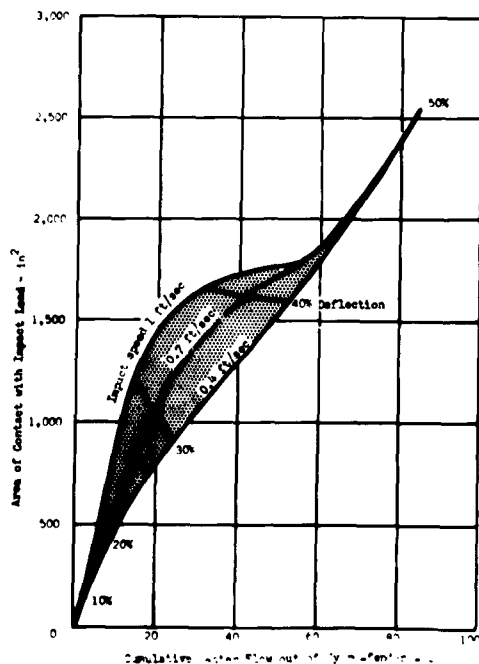
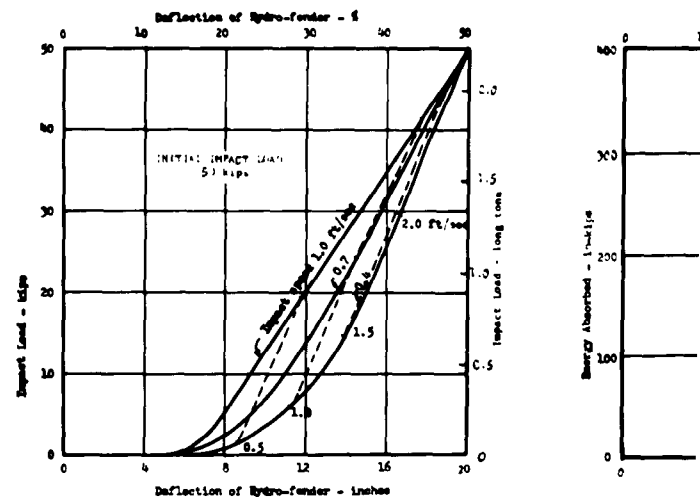
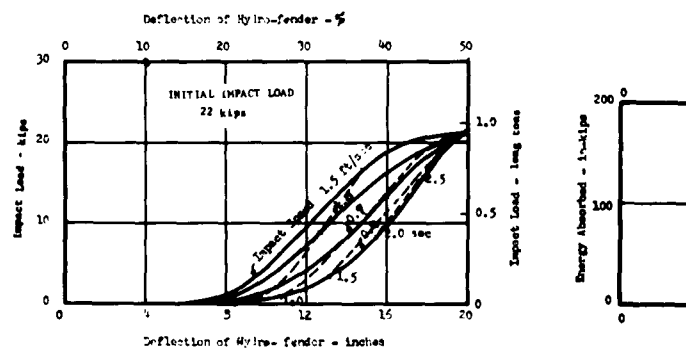
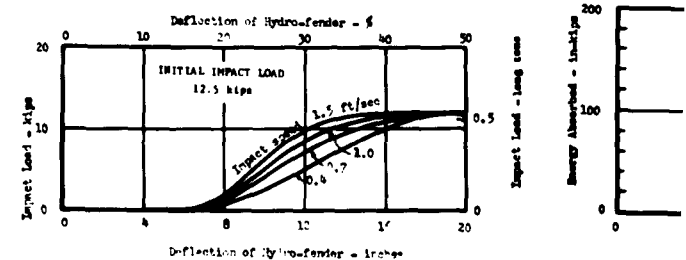
Figure 3. Energy-Absorbing Hydro Rubber S

(a) Pressure - Water Flow Relationship

(b) Water Flow - Deflection Relationship

(c) Deflection - Contact Area Relationship

(d) Load - Deflection Characteristics (Initial Impact Load = 50 kips)

(e) Load - Deflection Characteristics (Initial Impact Load = 22 kips)

(f) Load - Deflection Characteristics (Initial Impact Load = 12.5 kips)

The energy absorbed by each of the four water-filled rubber fenders is determined from load deflection characteristics (Figure 3) inferred from pressure measurements. The area of contact and deflection are related to the rate of flow by a calibration in which the discharge through the connecting tubes is directly related to the pressure measured.

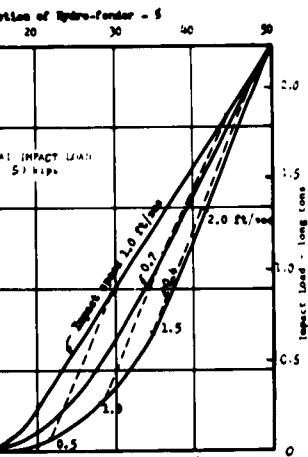
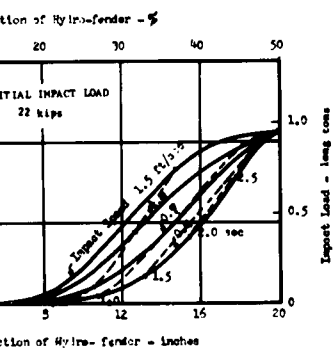
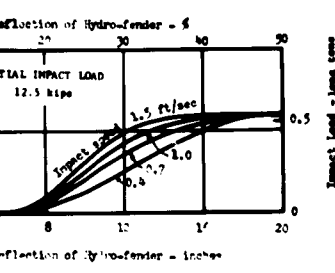
(g) Deflection Characteristics of Hydro-fender (Initial Impact Load = 50 kips)

(h) Deflection Characteristics of Hydro-fender (Initial Impact Load = 22 kips)

(i) Deflection Characteristics of Hydro-fender (Initial Impact Load = 12.5 kips)

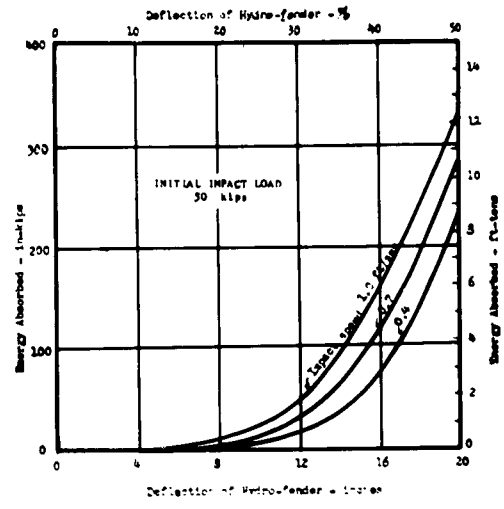
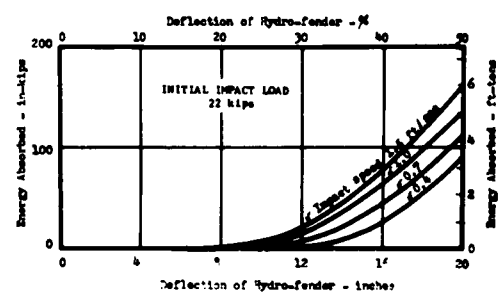
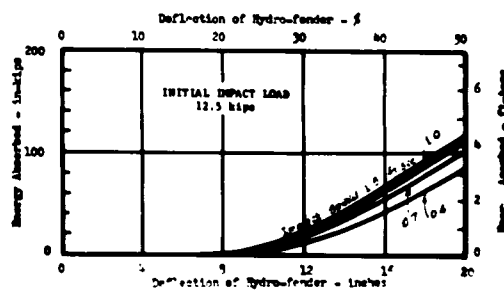
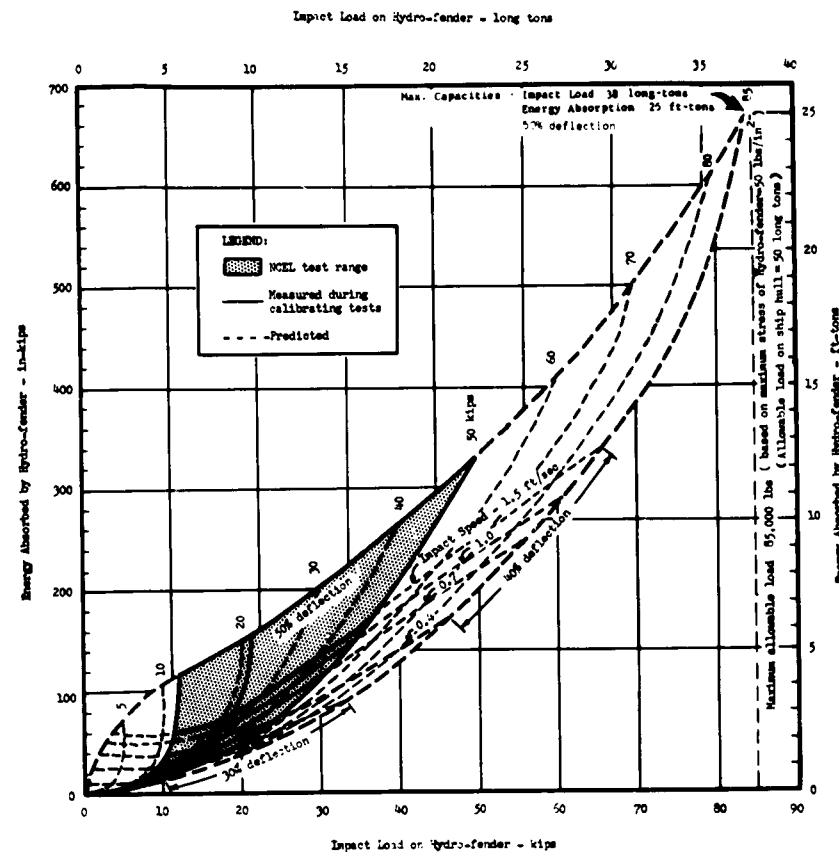
(g) Energy Absorption - Deflection Characteristics of Hydro-fender (Initial Impact Load = 50 kips)

(h) Energy Absorption - Deflection Characteristics of Hydro-fender (Initial Impact Load = 22 kips)

(i) Energy Absorption - Deflection Characteristics of Hydro-fender (Initial Impact Load = 12.5 kips)

(j) Energy - Absorbing Characteristics of a 40" x 60" Hydro Ship-Fender

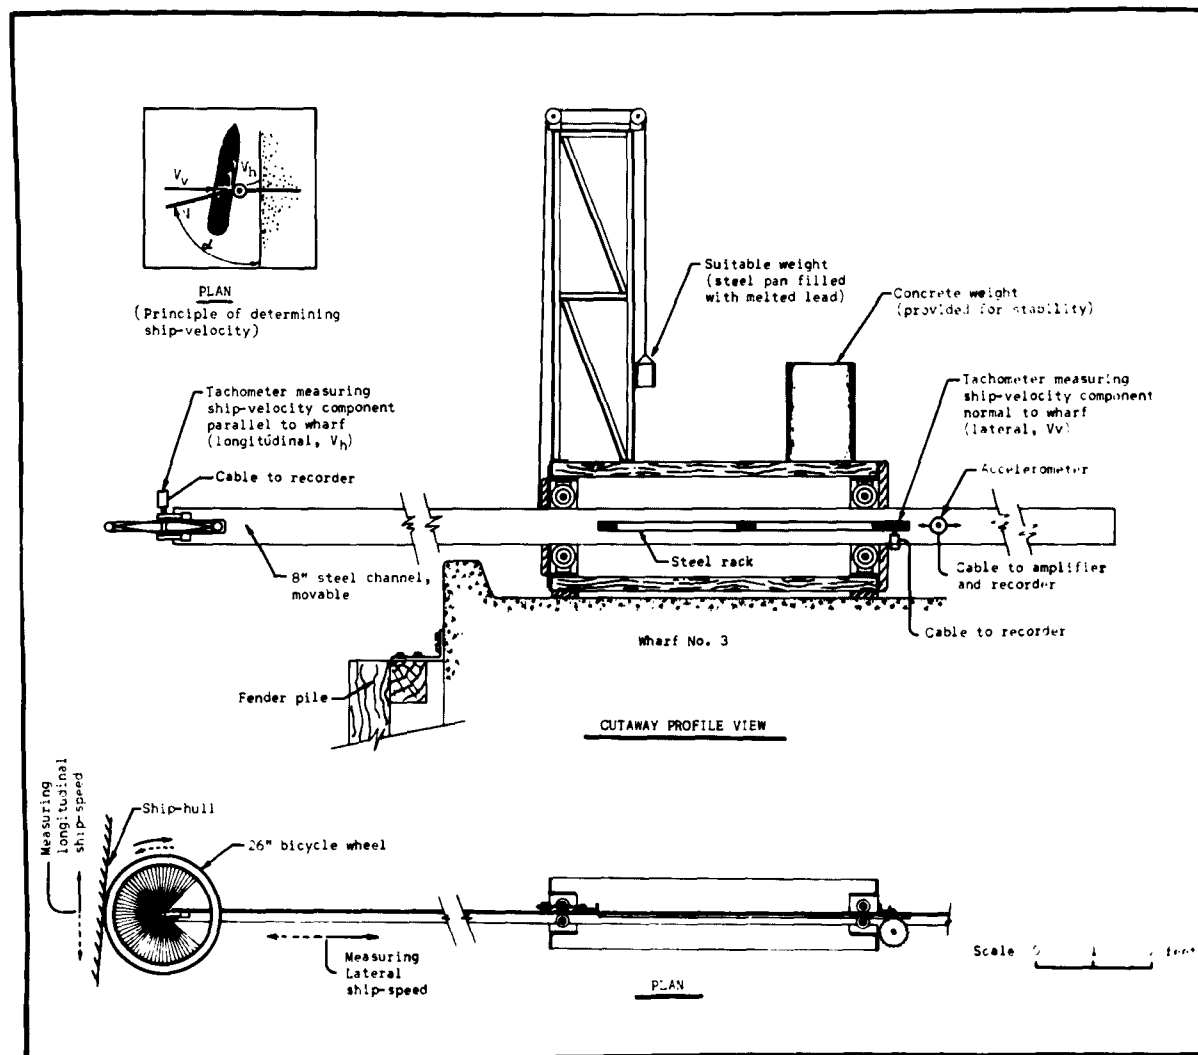
Figure 4 A Ship-Velocity Measuring Device

NOTE: This figure was prepared based on NCEL Dwg No. 62-34-1F and 62-34-2F, as modified.

The approach velocity of the test ships is measured electronically by means of two mutually perpendicular probes, each employing a tachometer as sensor. As shown in Figure 4, one probe, a steel channel, is pushed back laterally by the berthing ship; thereby the velocity component normal to the wharf is measured continuously. This probe extends approximately five feet beyond the camel fenders prior to the berthing operations. The other probe is a bicycle-wheel fastened to the steel channel probe, thereby the velocity component parallel to the wharf is measured. The wheel is turned by the berthing ship. Since the velocity components in two directions are measured, the angle and speed of approach is readily determined.

Ship acceleration perpendicular to the wharf is measured by one accelerometer fastened to the ship's side near the transverse axis of the center of gravity of the ship. In addition an accelerometer is fastened to the ship-velocity measuring probe.

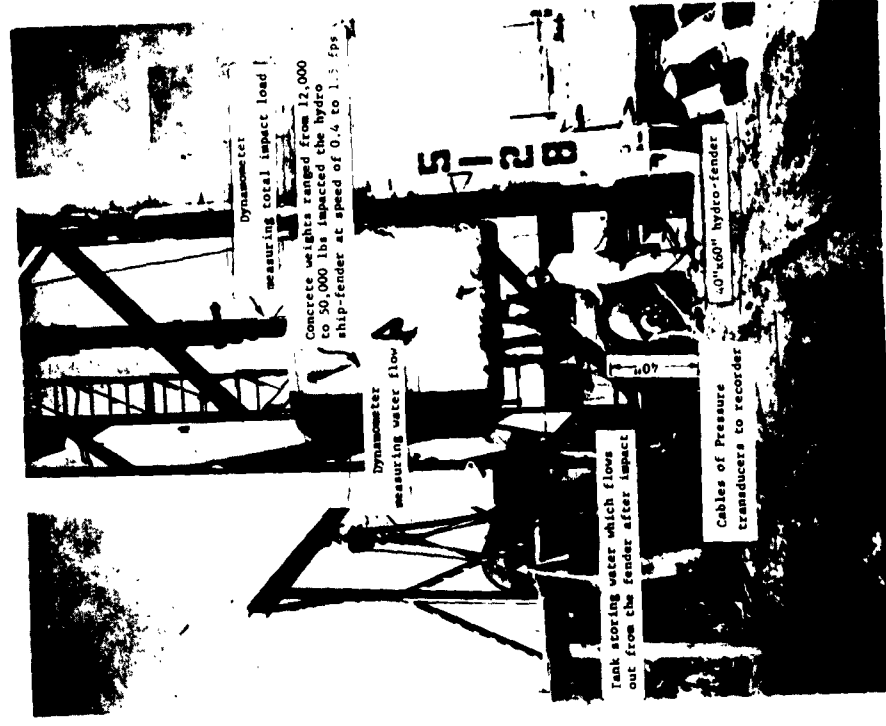
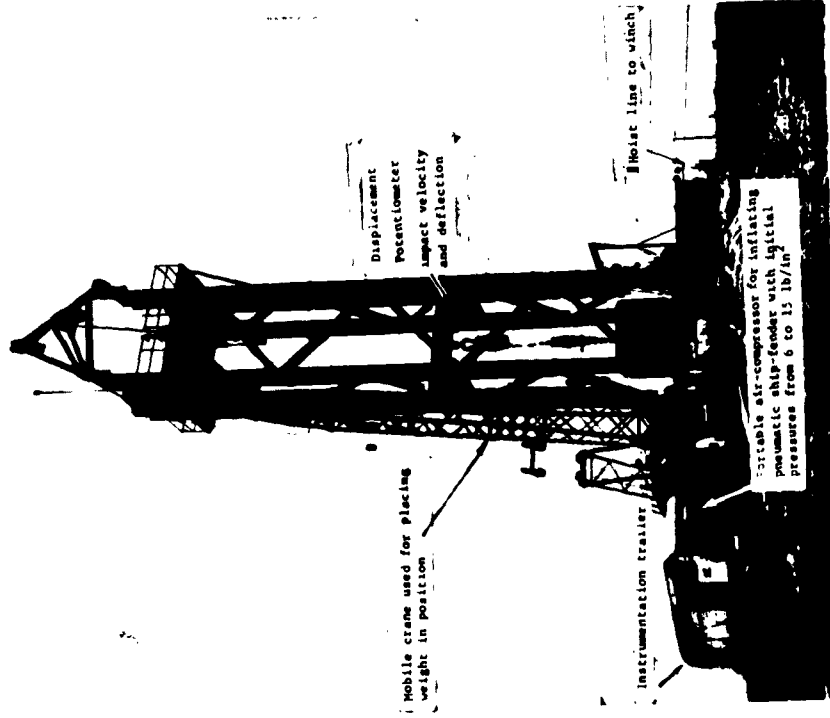
Figure 5 Testing Facilities Used for Calibrating Both Hydro and Pneumatic Rubber Ship-fenders (See also Figure 6)

(b) Concrete weight being elevated ready for testing of hydro and pneumatic rubber ship-fenders

(a) Long-pile testing tower used for calibrating

Calibration was done using a pile testing facility (Hromadik, 1961⁵ and Figures 5 and 6). Three loads ranged from 12,500 to 50,000 lbs were applied at speeds of from 0.4 to 1.5 feet per second.

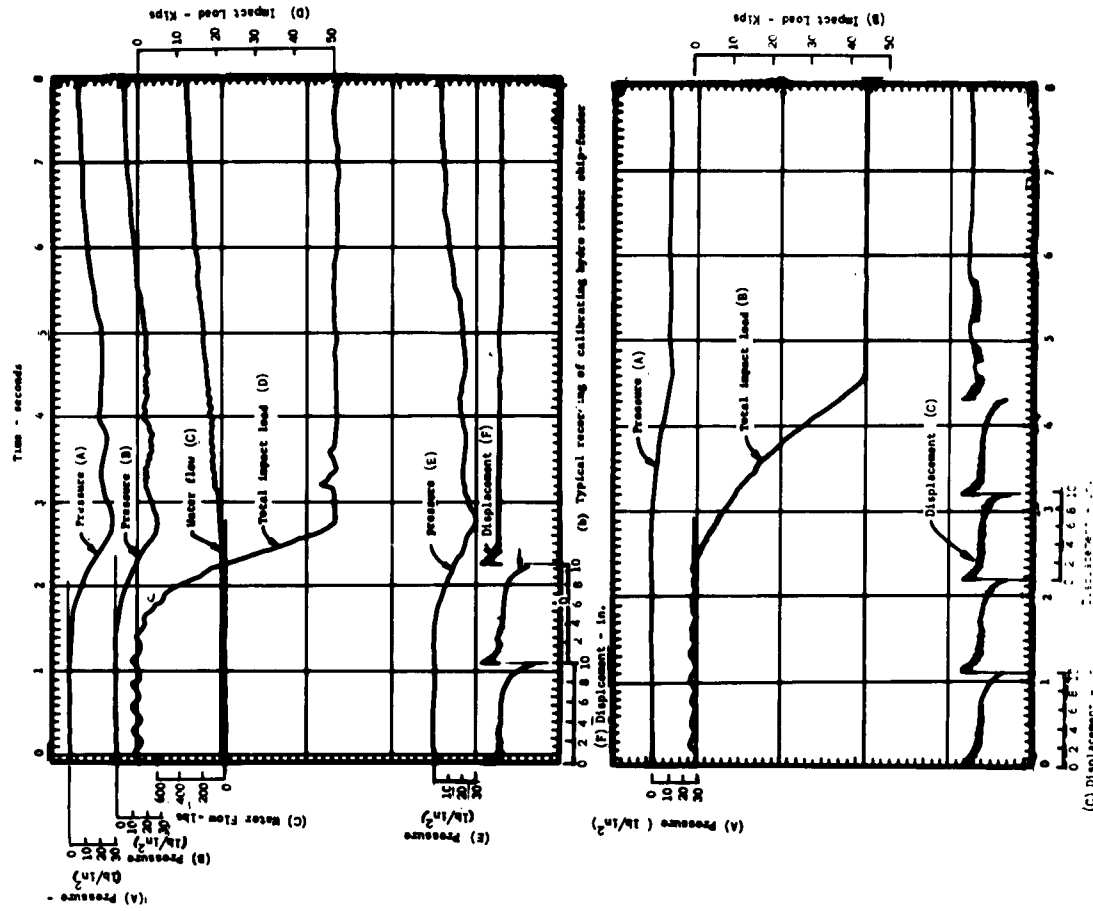
Figure 6 Testing Facilities Used for Calibrating Both Hydro and Pneumatic Rubber Ship-fenders (See also Figure 5)

(a) The hydro-fender deflected to 20" from original 40" diameter

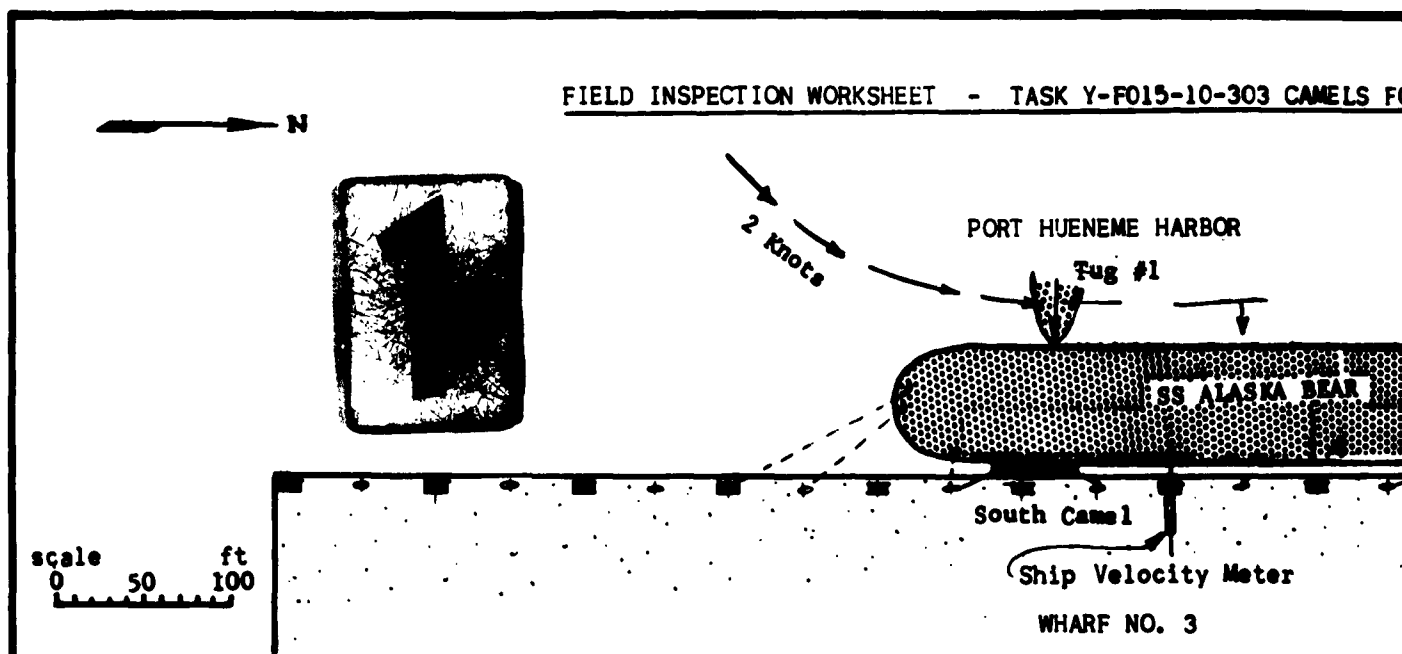
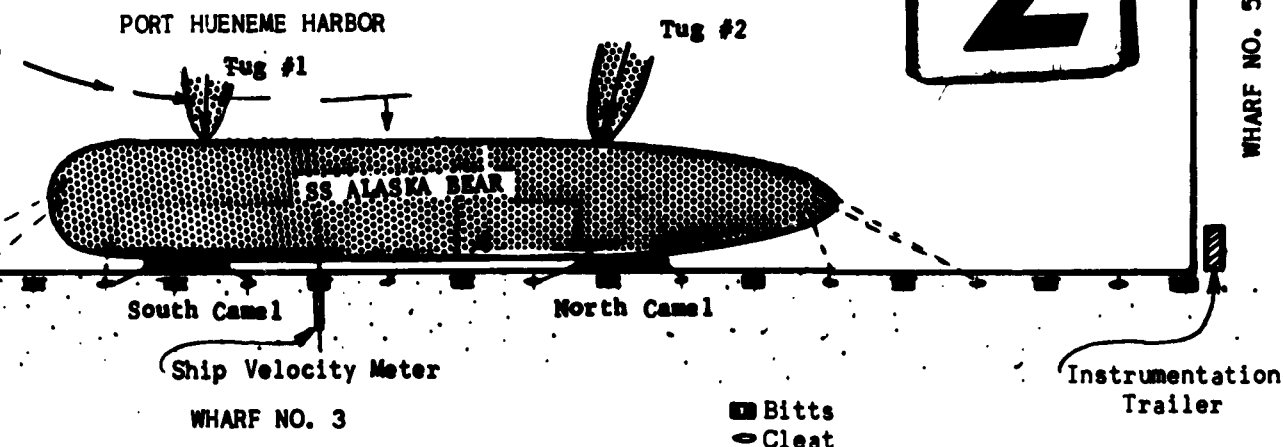
Figure 7 A Sample Field Inspection Worksheet

ENVIRONMENT		BERTHING SHIP CHARACTERISTICS
<p><u>Wind:</u> Speed 6mph Direction: 20-25°</p> <p><u>Wave:</u> <input checked="" type="checkbox"/> Calm <input type="checkbox"/> Moderate <input type="checkbox"/> Rough</p> <p><u>Current:</u> <input type="checkbox"/> Yes <input checked="" type="checkbox"/> No</p> <p><u>Tug-made Wave:</u> <input type="checkbox"/> Yes <input checked="" type="checkbox"/> No</p> <p>Tug speed: - knots</p> <p>Angle of approach - degrees</p> <p><u>Small:</u> <input type="checkbox"/> Yes <input checked="" type="checkbox"/> No</p> <p><u>Tide:</u> <input type="checkbox"/> High Gage +2 ft</p> <p><input type="checkbox"/> Mean</p> <p><input checked="" type="checkbox"/> Low</p>		<p><u>Names:</u> Ship: Alaska Bear Captain David L.</p> <p><u>Type:</u> Pacific Far East Line, Inc.</p> <p><u>Displacement:</u> Full 15,200 tons</p> <p>Berthing 8200 tons</p> <p><u>Length:</u> 455' 3"</p> <p><u>Beam:</u> 62'</p> <p><u>Draft:</u> Bow 10.5 ; Stern 22.5</p> <p>Mid-draft 28' 6 3/4" (full)</p>

GENERAL COMMENTS	SHIP CAPTAIN	<p>(1) The distance between the dock and ship berthed is considered too far but this would be satisfactory.</p> <p>(2) The normal boom capacities ranged from 5 tons to 50 tons for large boom. Small booms are not adequate.</p> <p>(3) The simple-log camel is considered adequate for most merchant ships. There is no problem with the log camel.</p> <p>(4) The high-pressure inside the rubber fenders might dent the ships hull.</p> <p>(5) It will be possible to break the bags by pin-pointing and longitudinal forces, (observed).</p> <p>(6) The test camels have the advantage of distributing impact load to fender piles but the test camels are not as effective as the log camel.</p> <p>(7) Consideration should be given to securing the rubber fenders directly to the fender piles.</p>
	PILOT AND OTHERS	<p>Capt. Fosse commented: (1) The cargo ship is too far away from dock for satisfactory berthing.</p> <p>(2) The rubber fenders will be subjected to tearing loose by barges.</p> <p>(3) The half-pipes welded on ship-hull (from scupper to the bow) are not adequate.</p> <p>(4) The test camels would work well in large harbor basins.</p> <p>Capt. Swanson commented: (1) There is a law that the maximum distance between dock and ship is 100 feet.</p> <p>(2) Rubber tubes hanging on fender piles would be better than the log camel.</p>

SUMMARY	<p>Capt. Parker is very cooperative, and pleasant to work with. It seems that the berthing was very careful. No wave and inertia impact observed. Only four bags of cement were used.</p>

A sample Field Inspection Worksheet completed for "SS Alaska Bear" is shown in Figure 7.

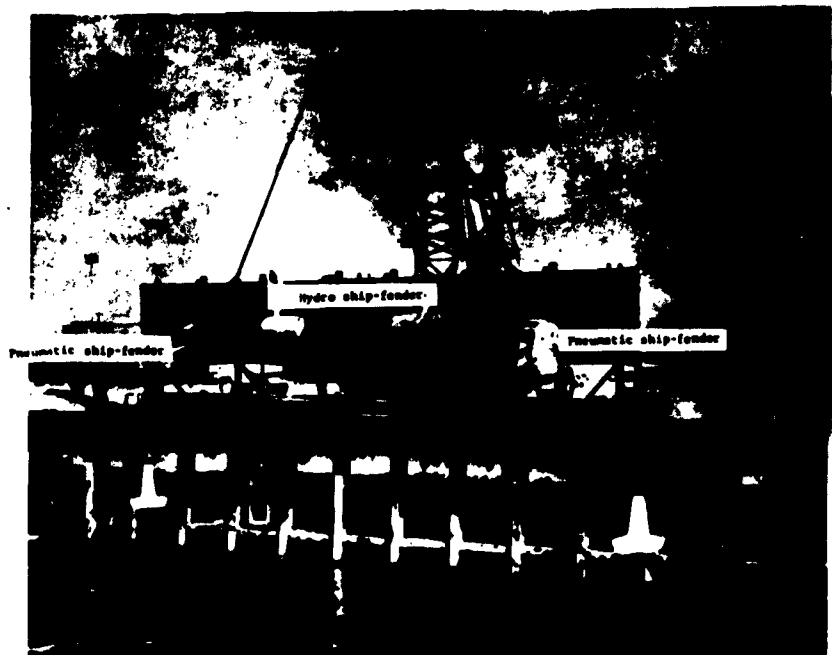
Figure 8 Installation and Operation of a Hydro-pneumatic Camel at Wharf No. 3, Port Hueneme Harbor, Calif. (See also Figure 9)

(a) A Single-log Camel Being Removed

(b) A Hydro-pneumatic Camel Being Installed

Two camels were fabricated at NCEL and installed on March 8, 1963 at Wharf No. 3 of the Port Hueneme Harbor, using a mobile crane, with a clear spacing of approximately 100 feet. Figures 8 and 9 show the camels during installation and operation, respectively. Figure 10

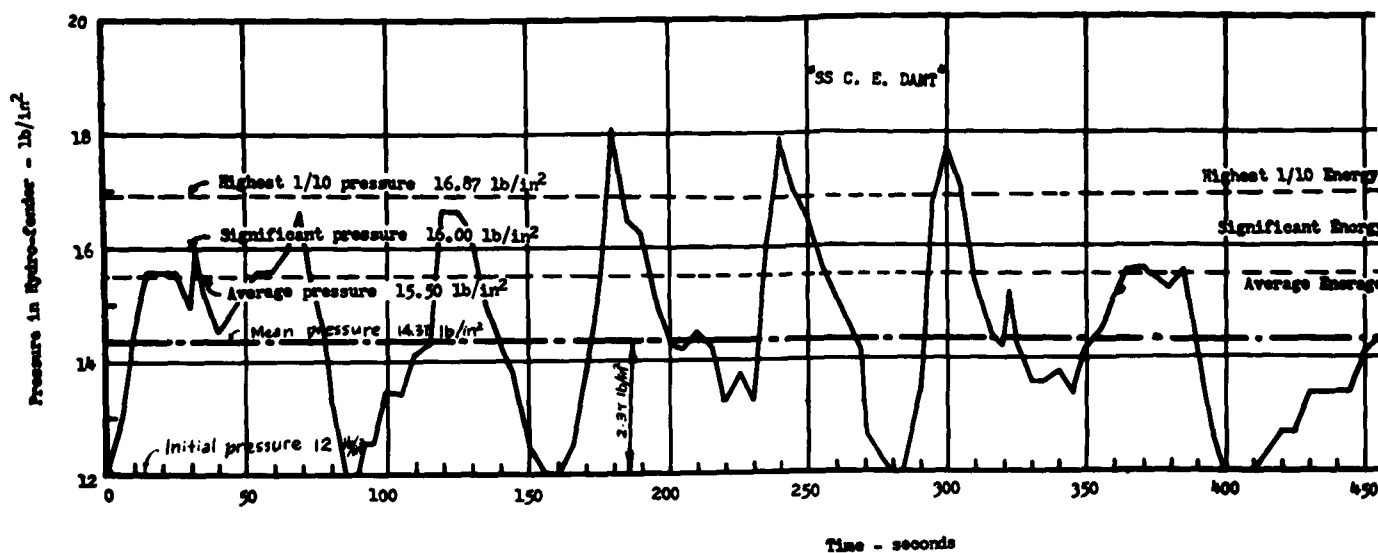
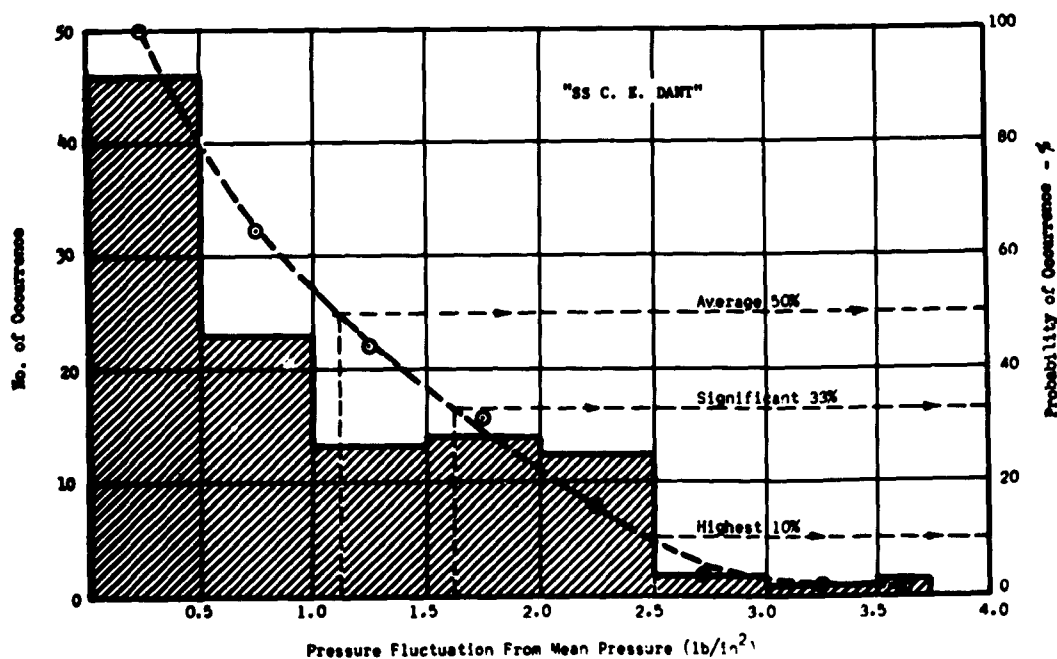
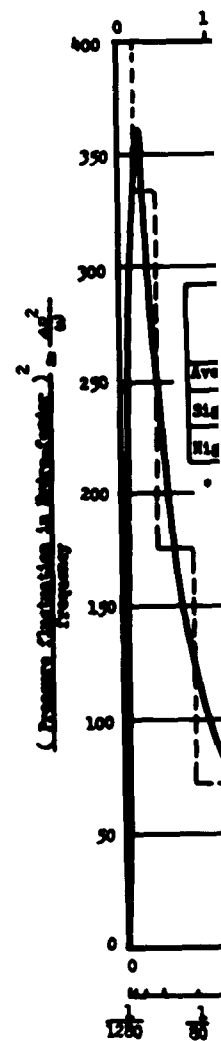
Figure 14 A Sample Spectral Analysis of Measured Pressures of a Pneumatic Fender.

(a) Pressure Fluctuations Recorded

(b) Frequency Analysis

The total load exerted by the rubber fenders was computed indirectly from the pressures measured. It varied from 4.2 to 24.6 long tons. The total kinetic energy absorbed was obtained from the summation of the energy absorbed by each individual rubber fender in contact with the berthing ship. It varied from 1.5 to 17 ft-tons which is from 4% to 42% of minimum designed capacity of the two camels. The energy-absorbing data is shown in Table II and Figure 15. A sample spectral analysis of measured pressures was made and the significant, average and highest one-tenth of energies absorbed were determined accordingly (Figure 14).

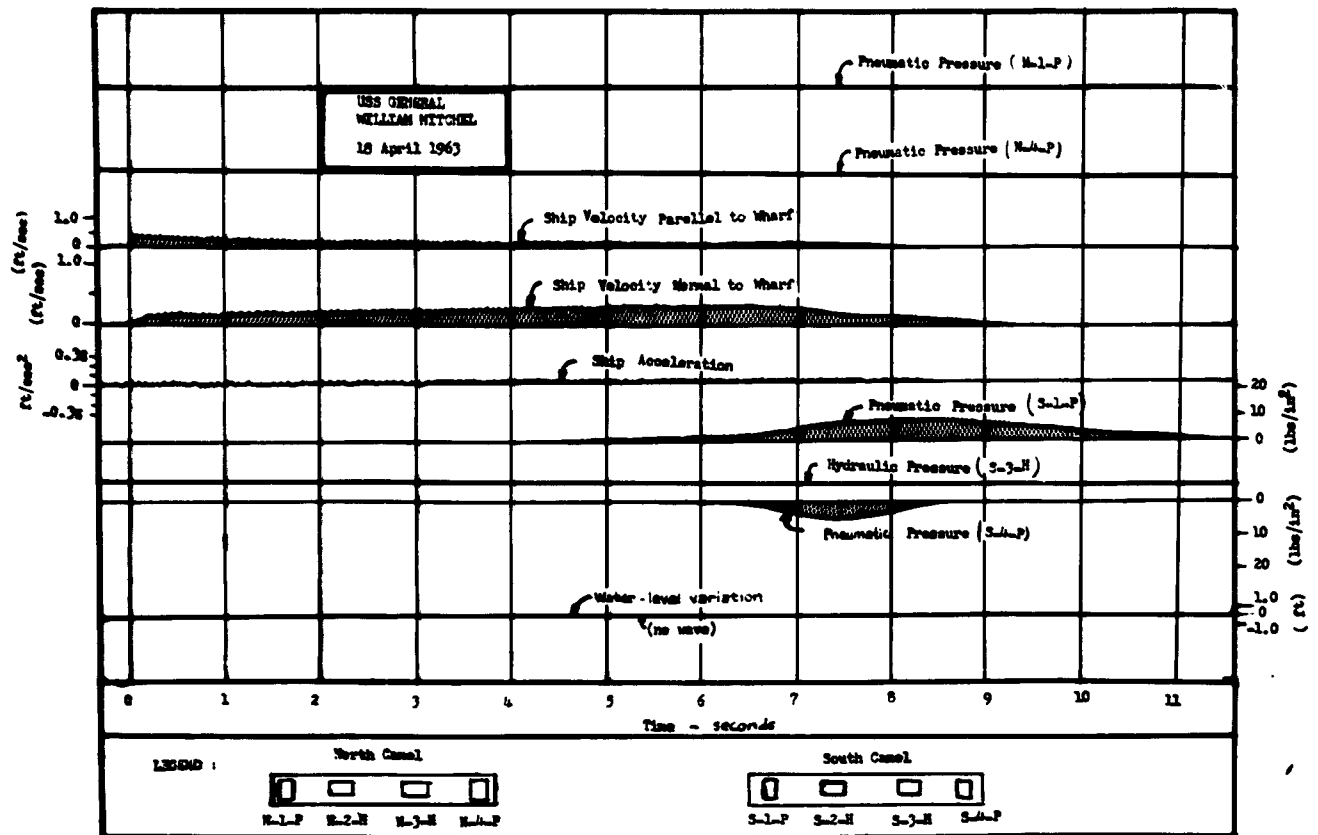
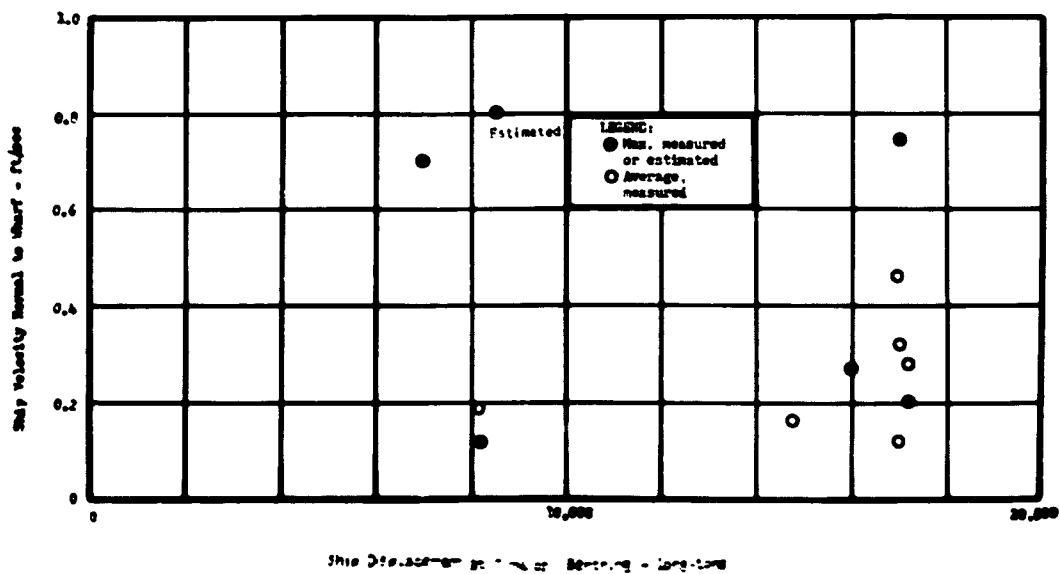
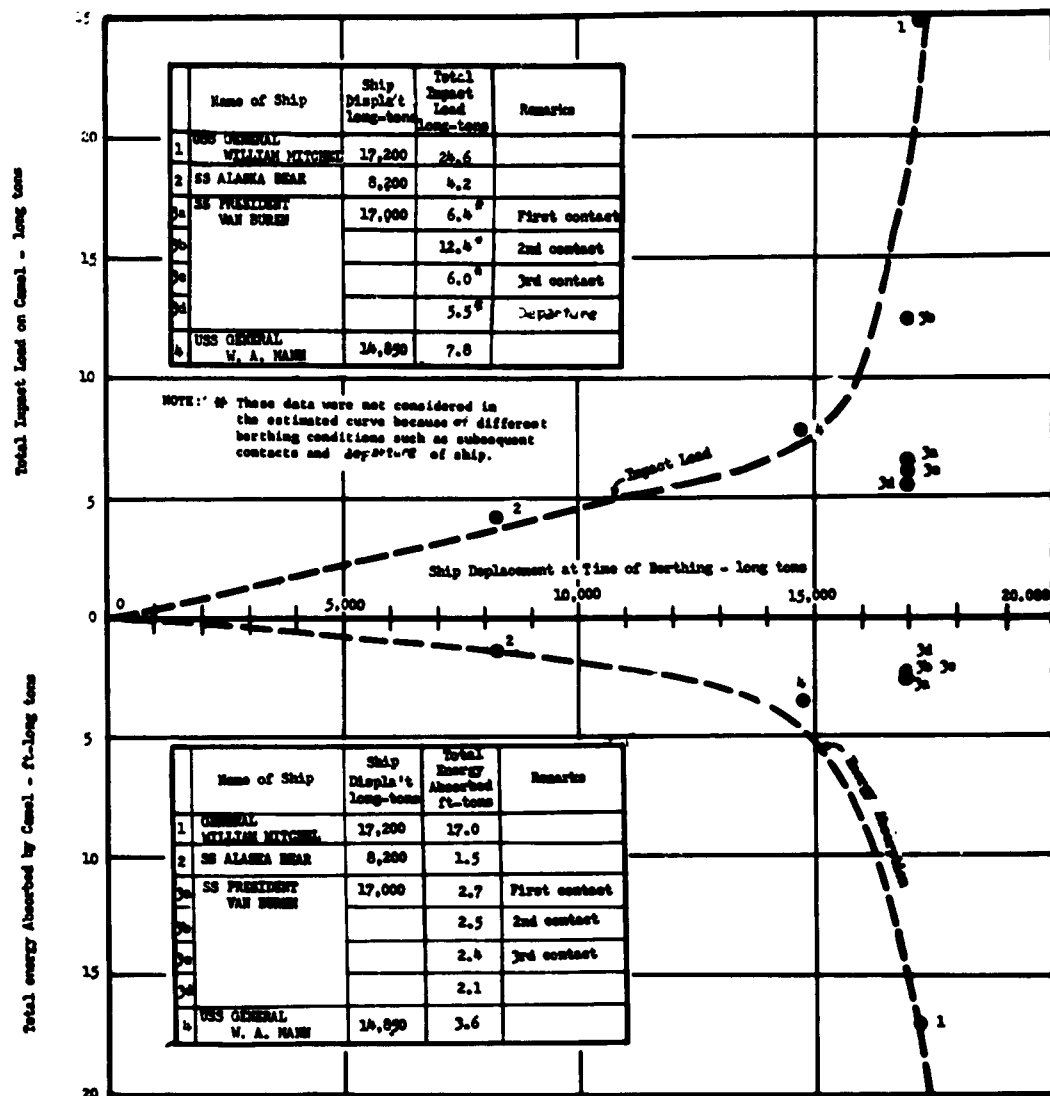
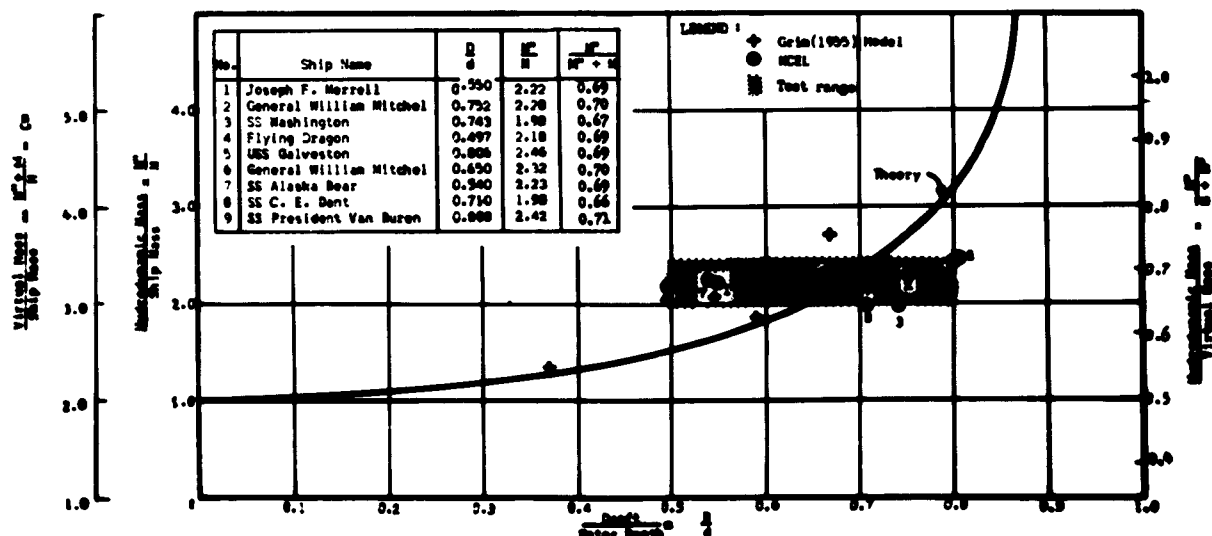
Figure 15 Summary of Results of Load Measurement and Inspection Program.

(a) Typical Recording of Field Measurements -
"USS General William Mitchell", 18 April 1963

(b) Ship Velocity Component Normal to Wharf

(c) Impact Load and Energy Absorption

(d) Hydrodynamic Masses
